Asbestos Management Survey for

Hansworth Uk Ltd

The Matrix Site
7 Solly Road
Fen Estate
Birmingham
B5 6RE

Project Number: C1005/01

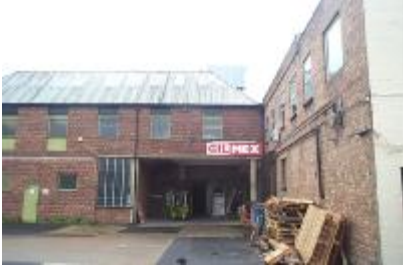
Damage: Low damage

Identification: Strongly Presumed

Quantity: 34m²

No Change

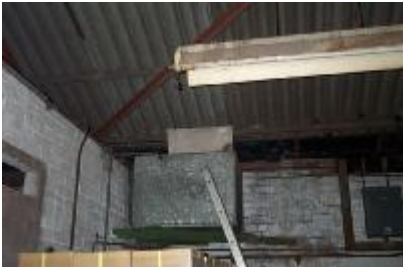
Damage: No visible damage

Identification: Presumed

Quantity: 10m²

Encapsulate and Apply Warning Labels

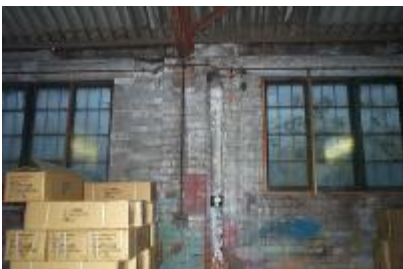
Damage: Low damage: Broken edge boards

Identification: Identified

Quantity: 56m²

Re-encapsulation

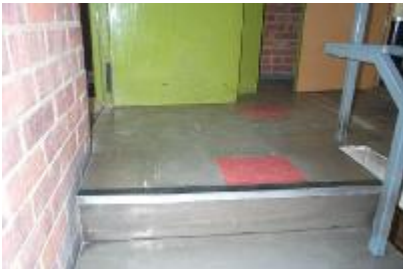
Location Ref: 03

Product Type: Asbestos cement

Damage: Low damage: Broken edge boards

Re-encapsulation

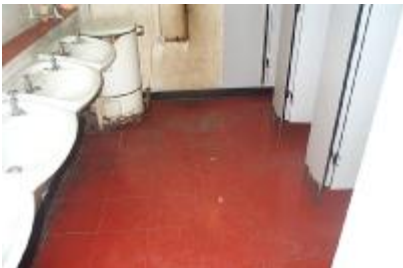
Location Ref: 04

Product Type: Vinyl floor tiles

Damage: Good condition

Minor deterioration but No Action Required

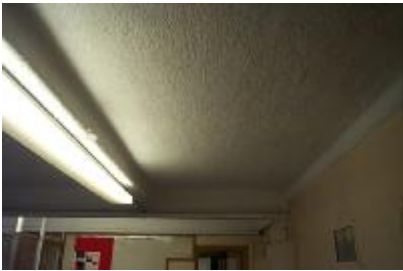
Location Ref: 06

Product Type: Asbestos cement

Damage: Low damage: Broken edge boards

Re-encapsulation

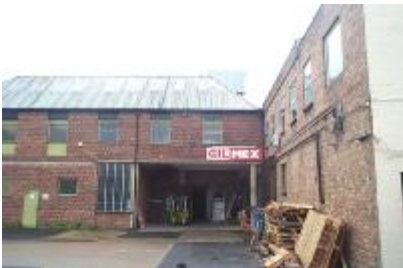
Location Ref: 20

Product Type: Roofing felts

Damage: Low damage: Broken edge boards

Apply Warning Labels

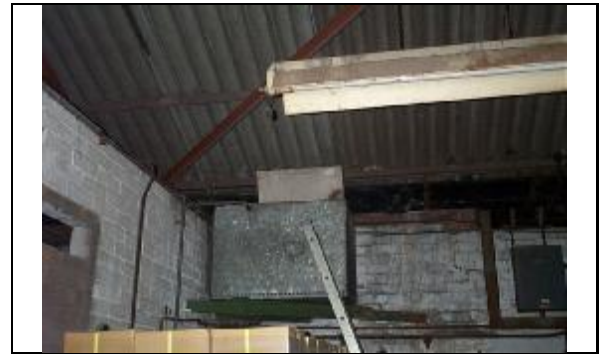
Location ID:	1
Location Ref:	01
Product:	Boarding
Area:	Not Applicable
Floor:	Basement
Room:	Activity area
Surveyor Name:	Tim
Drawing Ref:	12
Asbestos ?	Yes
Date:	01 January 2020

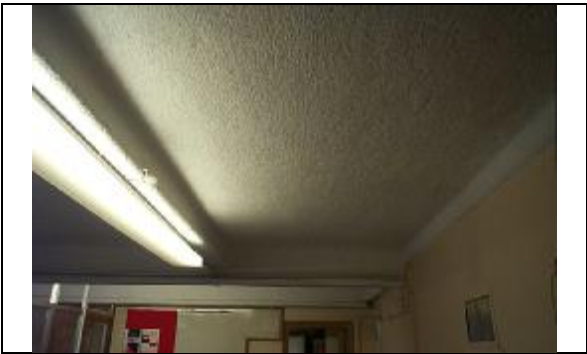
Location ID: 6
 Location Ref: 06
 Product: Beading
 Area: Building Two
 Floor: External grd floor
 Room: Activity area
 Surveyor Name: Tim
 Drawing Ref:
 Asbestos ? Yes
 Date: 23 March 2011

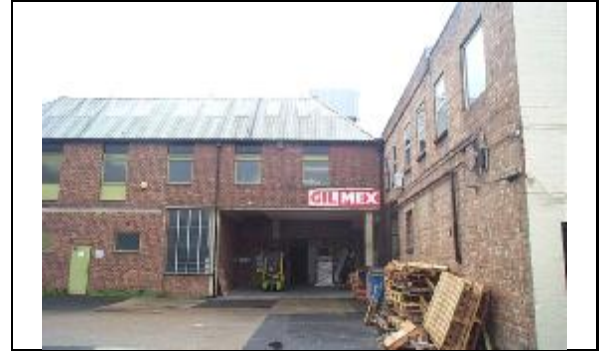
Location ID:	11
Location Ref:	20
Product:	Beading
Area:	Building Two
Floor:	External
Room:	Activity area
Surveyor Name:	Tim
Drawing Ref:	345
Asbestos ?	Yes
Date:	23 March 2011

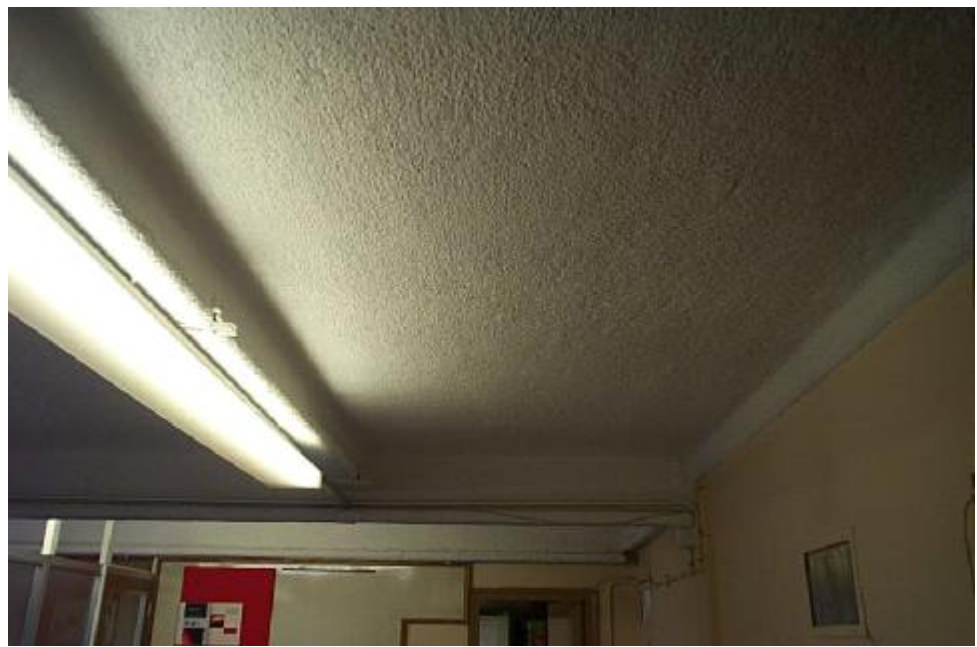
Location ID:	6	Removal Cost:	£4,300.90
Location Ref:	06	Survey Type:	RI
Product:	Beading	Product Type:	Asbestos cement
Area:	Building Two	Damage:	Low damage: Broken edge boards
Floor:	External grd floor	Treatment:	Enclosed sprays and lagging
Room:	Activity area	Asbestos Type:	Anthophyllite
Surveyor Name:	Tim	Identification:	Identified
Drawing Ref:		Quantity:	56m ²
Asbestos ?	Yes		
Date:	23 March 2011	Material Risk Score:	5
Next Inspection:	22 September 2011	Material Risk Band:	Low Risk
		Priority Risk Score:	3

Action:	Re-encapsulation
---------	------------------

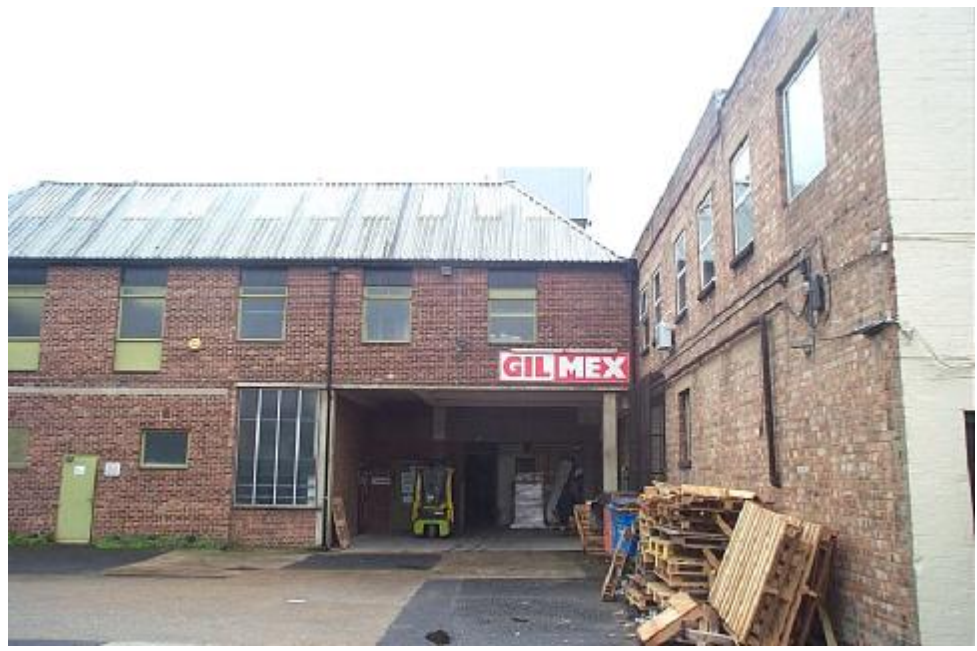
Location ID:	11	Removal Cost:	£0.00
Location Ref:	20	Survey Type:	RI
Product:	Beading	Product Type:	Roofing felts
Area:	Building Two	Damage:	Low damage: Broken edge boards
Floor:	External	Treatment:	AIB painted or encapsulated
Room:	Activity area	Asbestos Type:	Amosite/Crocidolite/Chrysotile
Surveyor Name:	Tim	Identification:	Presumed
Drawing Ref:	345	Quantity:	55m ²
Asbestos ?	Yes		
Date:	23 March 2011	Material Risk Score:	6
Next Inspection:	22 September 2011	Material Risk Band:	Low Risk
		Priority Risk Score:	4

Action:	Apply Warning Labels
---------	----------------------
